AIRCRAFT GROUND-FLOTATION INVESTIGATION

PART IX — DATA REPORT ON TEST SECTION 8

U. S. ARMY ENGINEER WATERWAYS EXPERIMENT STATION

TECHNICAL REPORT AFFDL-TR-66-43, PART IX

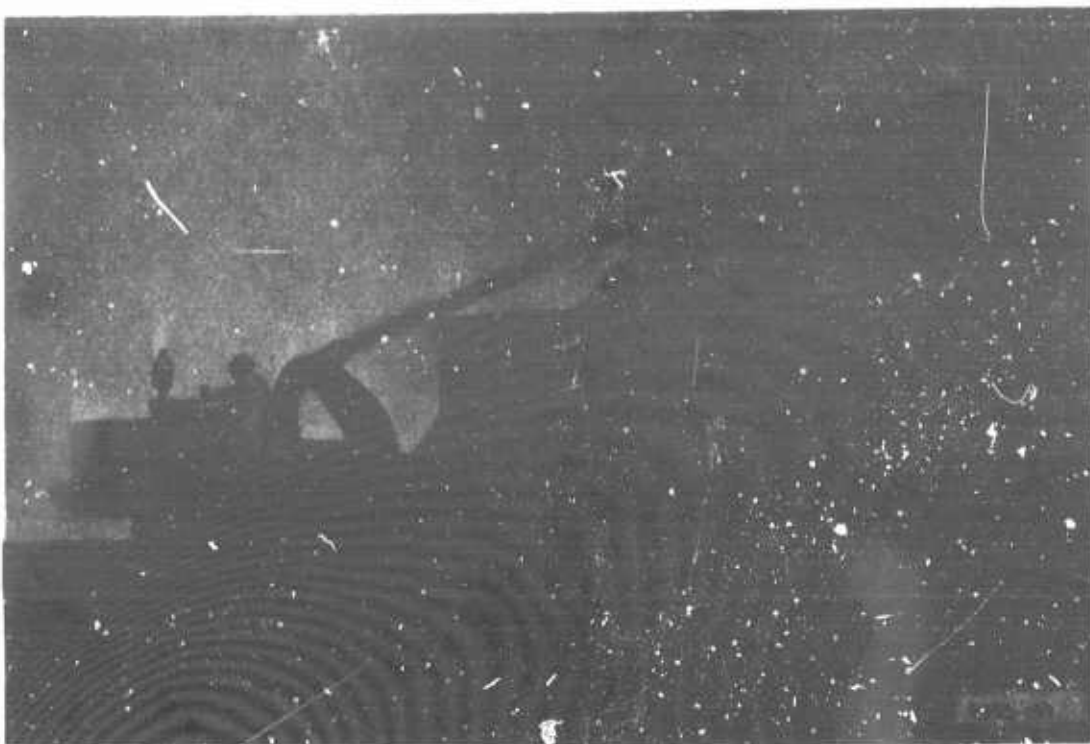
Figure 1. Test load vehicle

The load vehicle used for trafficking test lanes in Section 8 is shown in figure 1. Load cart construction, details of linkage between the load compartment and prime mover, and method of applying load are explained in Part I. For trafficking lanes 17, 17A, 18, 19, and 20, a 25,000-lb single-wheel load was used with the tracking tire inflated to 25, 100, 60, 40, and 80 psi, respectively. A 25.00x28, 30-ply aircraft tire was used on the assembly. Tire-print dimensions and pertinent tire characteristics are shown in figure 12.
